Q-4120-15-RP-003

Talinga Water Treatment Facility Water Quality Discharge Annual Report

(1 July 2010 to 30 June 2011)

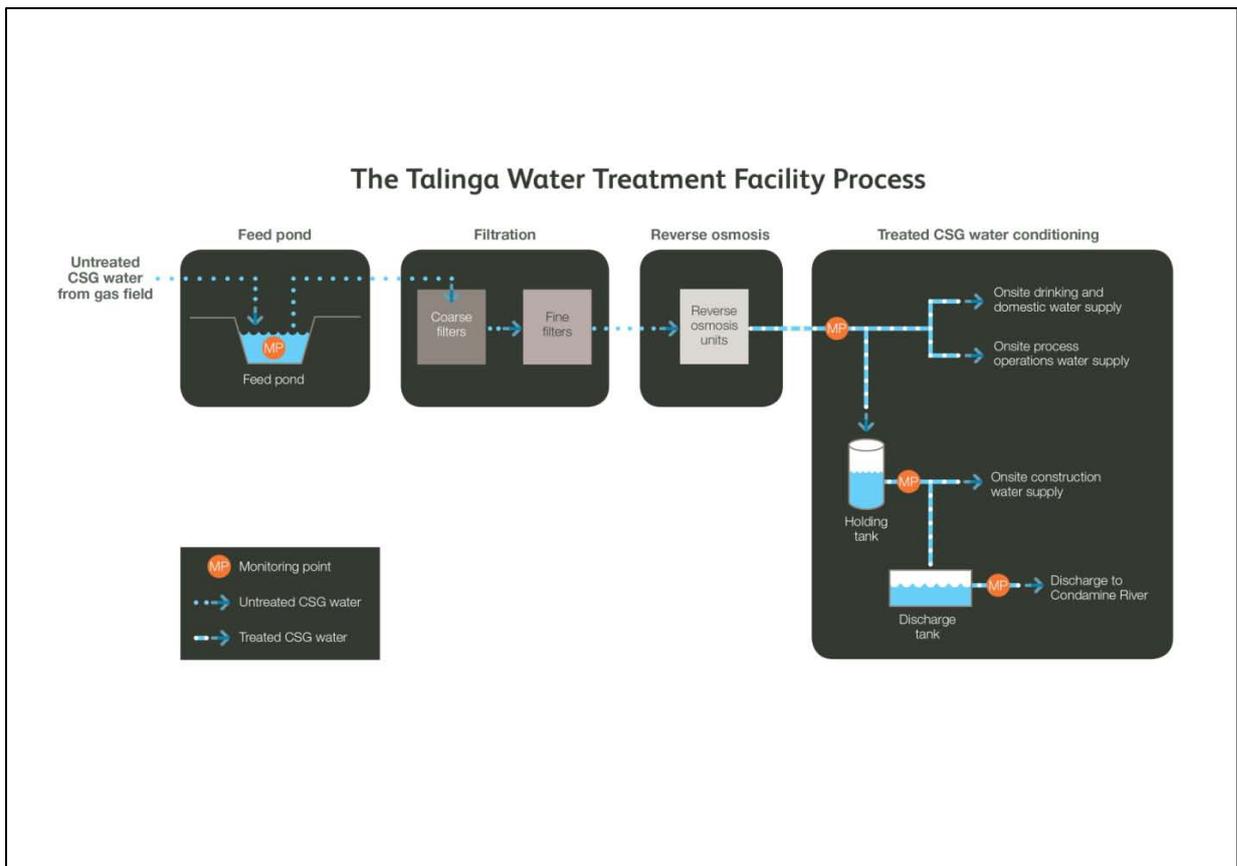
The TWTF uses a series of water screening, filtration and desalination processes to remove impurities from the CSG water to ensure its safety and reliability for supply into a drinking water source and beneficial uses. The key treatment processes include:

- Feed pond;
- Filtration;
- Reverse osmosis; and
- Treated CSG water conditioning.

Figure 2 - TWTF Process Schematic

Untreated CSG water gathered from the gas field is temporarily stored in a feed pond prior to its treatment by the TWTF. The feed pond holds the CSG water for approximately one to two weeks. This allows the settlement of coarse suspended sediments and provides opportunity for the CSG water to aerate and oxygenate.

The CSG water is then passed through a coarse filter and then a fine filter to remove any particles or suspended sediments that have not settled within the feed pond. A disinfectant commonly used in domestic water treatment facilities is also added prior to the filtration process to protect the treatment system and membranes used in the following reverse osmosis process.

Reverse osmosis involves passing the CSG water through fine membranes at high pressure. This removes most of the dissolved salts and other trace elements.

At this point the water is either transferred to a holding tank, where it is held prior to discharge or piped for use onsite.

Prior to entering the holding tank, the pH of the treated CSG water is adjusted to ensure its suitability for use and the disinfectant added during the filtration process is removed.

Where the treated CSG water is discharged to the Condamine River calcium and magnesium salts are added. This conditioning is undertaken to ensure a minimum level of these elements is present in the Condamine River to protect the environment. These natural salts are normally present at much higher concentrations in river waters and municipal drinking water supplies.
